Manhole Inspection Summary

Manhole # S27I__039MH

Insp Date: **5/28/08 8:19 AM**

Location Address: **114 Parkin St**

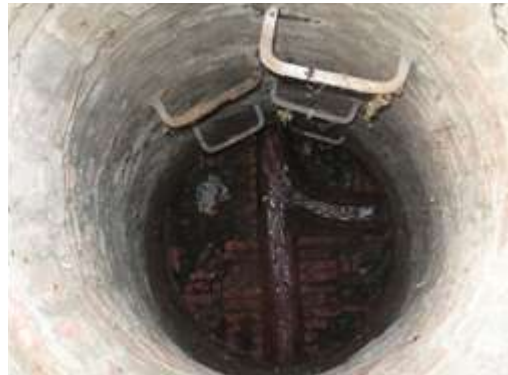
Top View

Debris on bench.

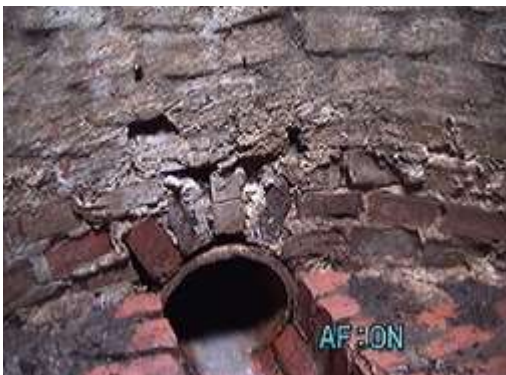
Defect 3

Condition: ☐ Sound ☐ Cracked ☐ Root Intrusion ☐ Loose Brick ☒ **Deteriorated**

Infiltration: ☐ None ☐ Joint ☐ Cracks ☐ Mortar ☐ Roots ☒ **Wall**

barrel cond deteriorated, barrel flow wall

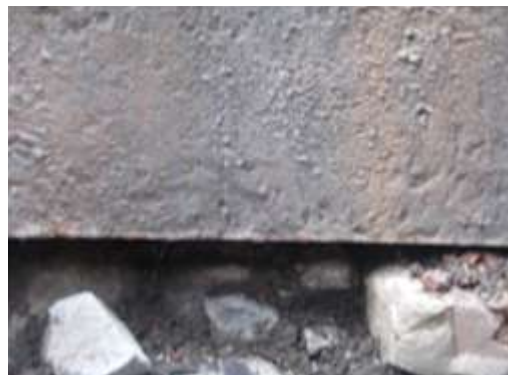
Defect 2

Condition: ☐ Sound ☒ **Cracked** ☐ Root Intrusion ☒ **Loose Brick** ☐ Deteriorated

chimney cond loose brick, cracks, mortar

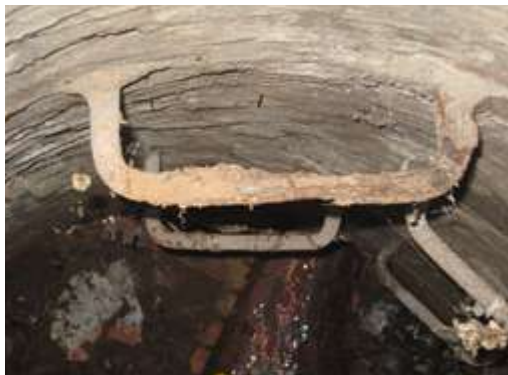
Defect 1

Count: **5** Missing: **0** ☒ **Corroded**

corroded steps

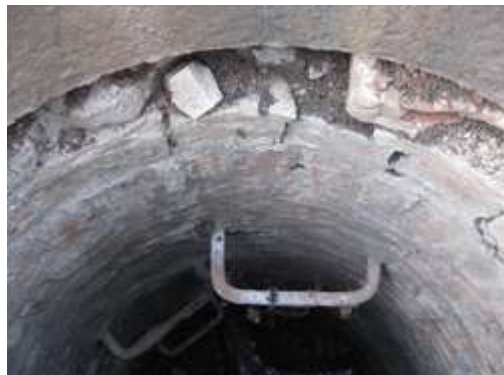
Defect 4

Offset: **1.** (in.)
25

Frame offset 1.25 inch
